## Report on Pavement Investigation

Designation: Stardust Pavement Evaluation

Location: Stardust Trail  
Flagstaff, AZ

Project Number: 220184SF

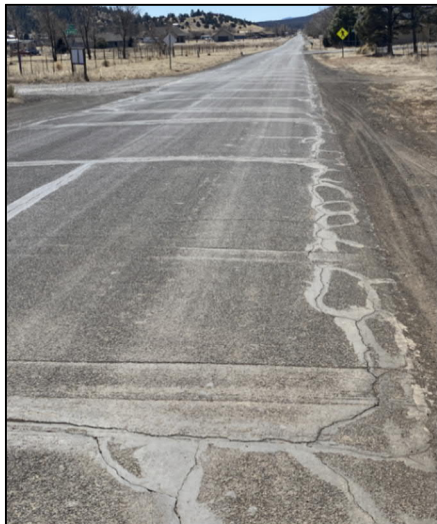
**Figure 2.1.2 – Northern Section**

The primary distress observed was transverse and longitudinal shrinkage cracking, which is typical in all asphalt pavements. In many areas in the north and central sections, longitudinal cracking has progressed to block and alligator cracking. The alligator cracking is possibly a sign of subgrade destabilization. Lacking a paved shoulder, there is also cracking along the edge of the pavement, likely a result of moisture fluctuations and lack of lateral support along the edges of the pavement. In general the types of distress observed are typical of aging asphalt based pavements. As the asphalt binder (oil) ages, the mix becomes stiffer (less flexible) to the point where the pavement can no longer tolerate the daily shrinkage forces that result from temperature changes. These types of cracks do not typically represent structural failure. However overtime, as moisture enters into the base and subgrade, through the cracks,

the pavement can further deteriorate and result in the formation of “alligator” cracking (**Figure 2.1.2 & 2.1.3**). This type of progression appears to have occurred extensively in the north and central sections. Some minor evidence of rutting and warping of the road surface was also observed. Maintenance history was unavailable, however based on the field observations and the general condition of the pavement, it appears that some effort to maintain the pavement has been made by placement of a chip seal and some crack sealing.

As indicated above, the pavement in the north and central section is generally in fair to poor condition and pavement in the southern section is in fair to good condition. Based on available information, the north and central sections may have been constructed over a number of years using various surface treatments. Structurally, it appears that the pavement is performing adequately, given the assumed low traffic volumes. However, there is some evidence of rutting along portions of the road and some of the longitudinal and transverse cracking has further progressed into alligator cracking. This is likely due to moisture infiltration and the very loose subgrade conditions. While difficult to evaluate due to the chip seal surface, it appears that much of the distress observed in the pavement is related to primarily due to environmental factors (oxidation, ponding, and moisture infiltration) and less related to being overloaded, with the exception of some of the northern and central sections of the road where there is alligator cracking present.

Patching of failed areas or pop-outs will likely be required as part of the pavement rehabilitation. This may be done to address the failed areas prior to placement of a surface treatment or as a result of pop-outs after the milling process has been completed. Full depth patching should be completed prior to conducting any crack filling. For the area north of Silver Saddle, this is the primary recommendation.

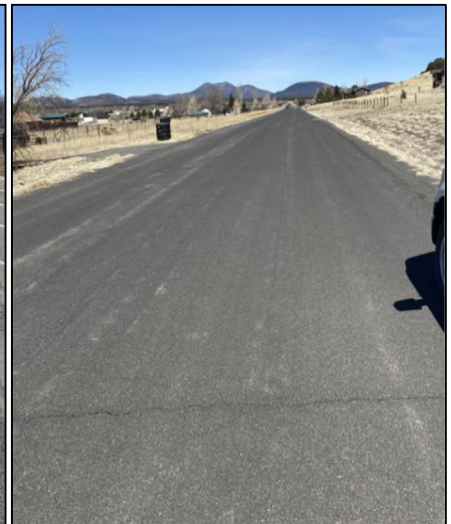
**Figure 2.1.4 – Southern Section**

For the south section of the roadway, between Silver Saddle and Yancey, the majority of the pavement is performing adequately. The primary forms of distress are related to the aging of the pavement. Based on these conditions, one option for rehabilitation of the pavement would be to conduct a surface treatment, which would be considered more of a maintenance item. This could consist of a slurry seal or a chip seal. These procedures are primarily used as part of a maintenance routine and would be required every 3-7 years. Note, the current pavement structure does not meet the Coconino County minor collector roadway classification that is proposed by the traffic study, although based on the traffic analysis, the section appears to be sufficient.

Alternatively, a chip seal surface treatment, such as what is used more recently, could also be considered. If selected, the asphalt chip seal should follow the recommendations outlined in MAG Specification Section 330.
