FINAL GEOTECHNICAL REPORT

ADOT Project No. 040 AP 351 F0319 01D

I-40; Allentown TI UP Bridge # 20246 Replacement

July 5, 2022

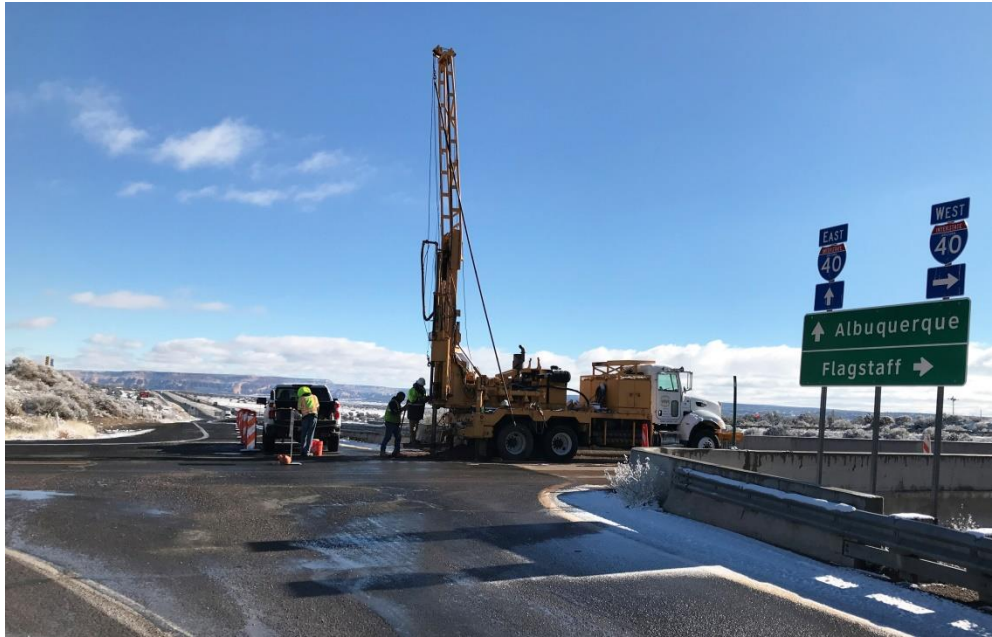
Figure 2: Drilling activities near the location of Abutment 1

The subsurface soils were then sampled with a split spoon sampler (STP) or with a ring-lined barrel sampler. The sampling was completed at intervals of 5 feet using mostly 2-inch O.D., 1.4-inch inside diameter (I.D.) samples to obtain the standard penetration resistance. Relatively undisturbed samples were also obtained with 3-inch O.D. samples lined with 2.42 inch I.D. brass rings.

The SPT and ring samplers were driven 18 and 12 inches, respectively, or to refusal (i.e. 50 blows for less than a 6 inches of sampler penetration) using an automatic hydraulic actuated 140 pound hammer free falling 30 inches. Unless noted otherwise on the boring logs, the sample driving resistance was recorded as number of blows per six inches of penetration. The results of the penetration tests are presented on the borings logs provided in the appendix of this report.

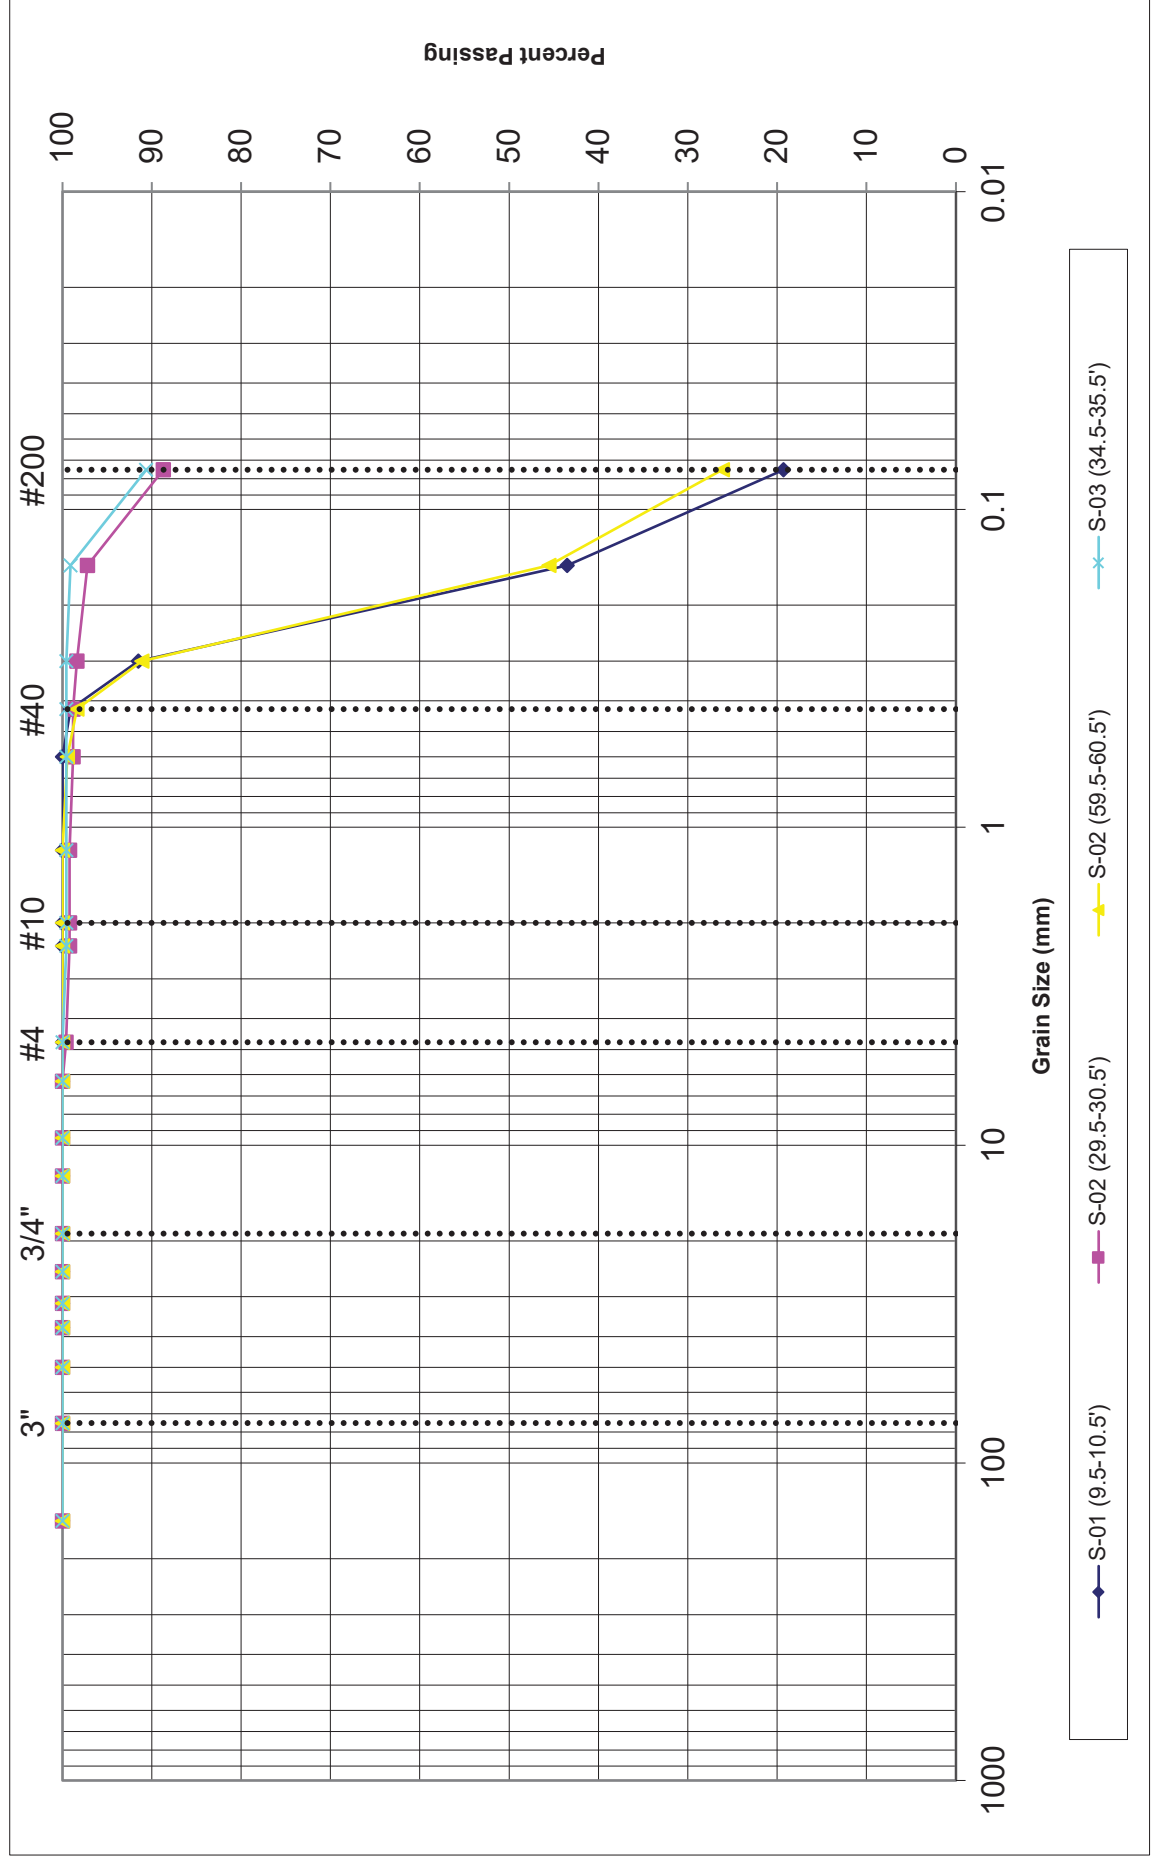
MECHANICAL SIEVE ANALYSIS GRAPHS

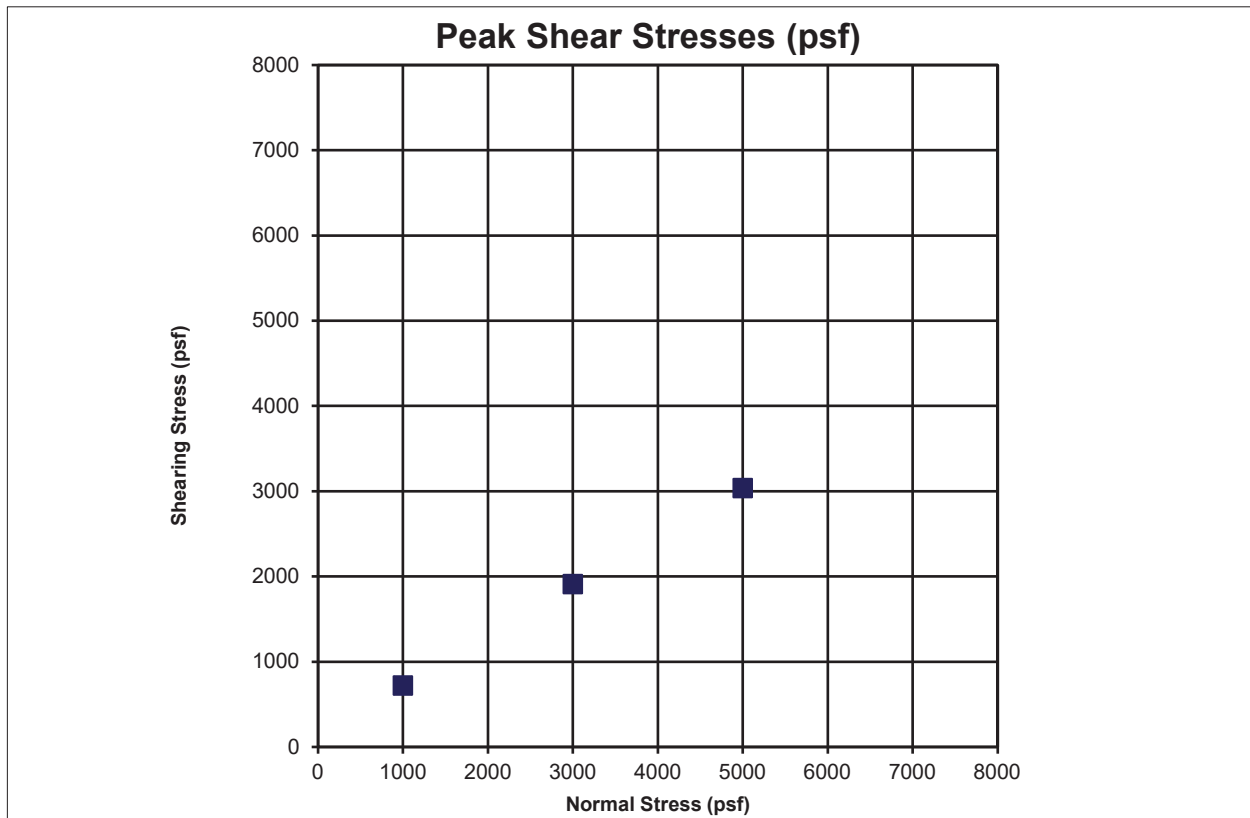
DIRECT SHEAR TEST OF SOILS UNDER CONSOLIDATED DRAINED CONDITIONS (ASTM D3080)

Initial thickness of specimen (in.):	1.00	1.00	1.00
Initial diameter of specimen (in.):	2.42	2.42	2.42
Final thickness before shear (in.):	0.994	0.997	0.993
Shearing device used: Humboldt Automated Shear Test System by Trautwein Soil Testing Equipment			
Rate of deformation (in/min):	0.01	0.01	0.01
Direct shear point:	1	2	3
Dry mass of specimen (g):	115.5	115.4	115.9
Initial Moisture Content:	5.4%	5.9%	7.9%
Initial Wet Density (pcf):	100.8	101.2	103.6
Initial Dry Density (pcf):	95.7	95.6	96.0
Final Moisture Content:	21.4%	21.8%	19.8%
Final Wet Density (pcf):	116.8	116.8	115.8
Final Dry Density (pcf):	96.2	95.8	96.7
Normal Stress (psf):	1000	3000	5000
Maximum Shearing Stress (psf):	719	1911	3039
Vertical Deformation @ Max Shear (in):	4.752	0.226	0.243
Horizontal Deformation @ Max Shear (in):	0.116	0.483	0.483

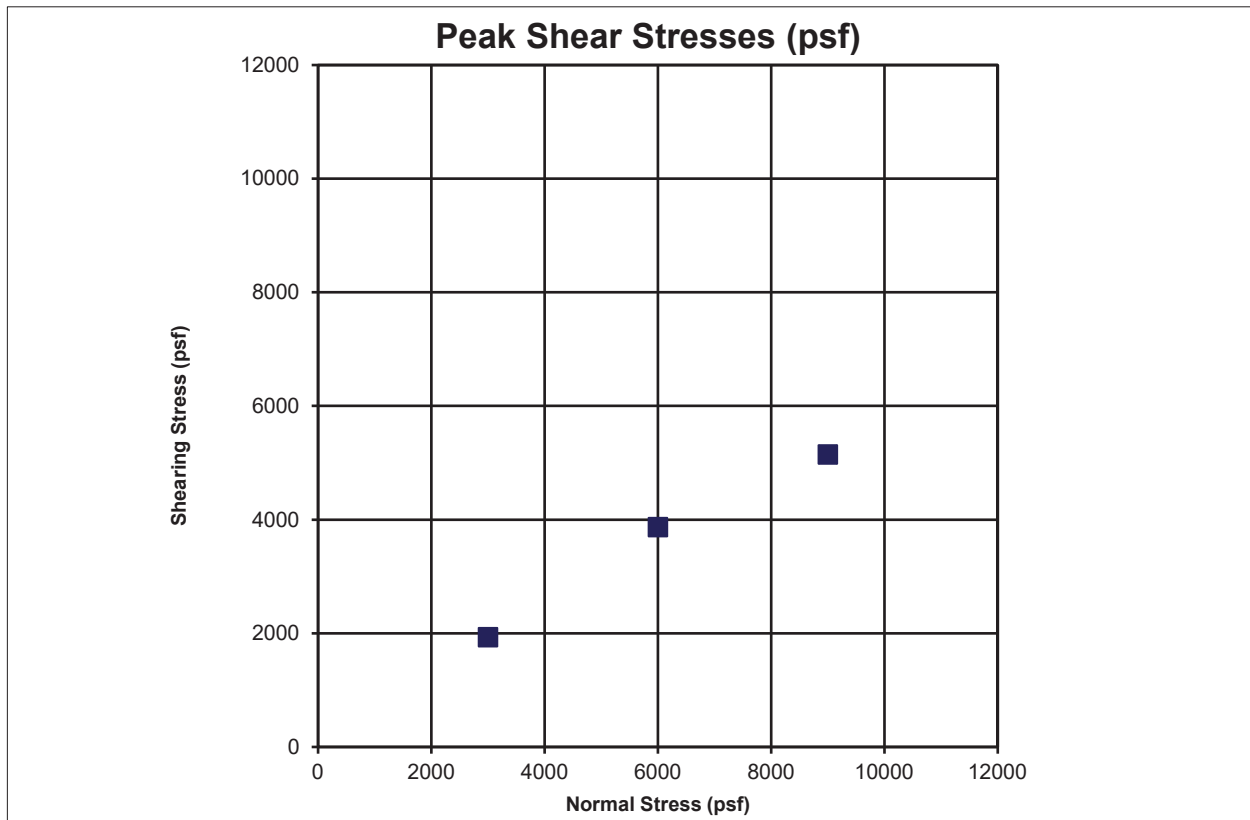
DIRECT SHEAR TEST OF SOILS UNDER CONSOLIDATED DRAINED CONDITIONS (ASTM D3080)

Initial thickness of specimen (in.):	1.00	1.00	1.00
Initial diameter of specimen (in.):	2.42	2.42	2.42
Final thickness before shear (in.):	0.987	0.973	0.979
Shearing device used: Humboldt Automated Shear Test System by Trautwein Soil Testing Equipment			
Rate of deformation (in/min):	0.0015	0.0015	0.0015
Direct shear point:	1	2	3
Dry mass of specimen (g):	107.0	113.5	116.4
Initial Moisture Content:	32.0%	29.0%	26.7%
Initial Wet Density (pcf):	116.9	121.3	122.2
Initial Dry Density (pcf):	88.6	94.0	96.4
Final Moisture Content:	31.5%	27.0%	26.0%
Final Wet Density (pcf):	118.1	122.6	124.2
Final Dry Density (pcf):	89.8	96.6	98.5
Normal Stress (psf):	3000	6000	9000
Maximum Shearing Stress (psf):	1931	3870	5144
Vertical Deformation @ Max Shear (in):	0.175	0.204	0.247
Horizontal Deformation @ Max Shear (in):	0.057	0.121	0.211

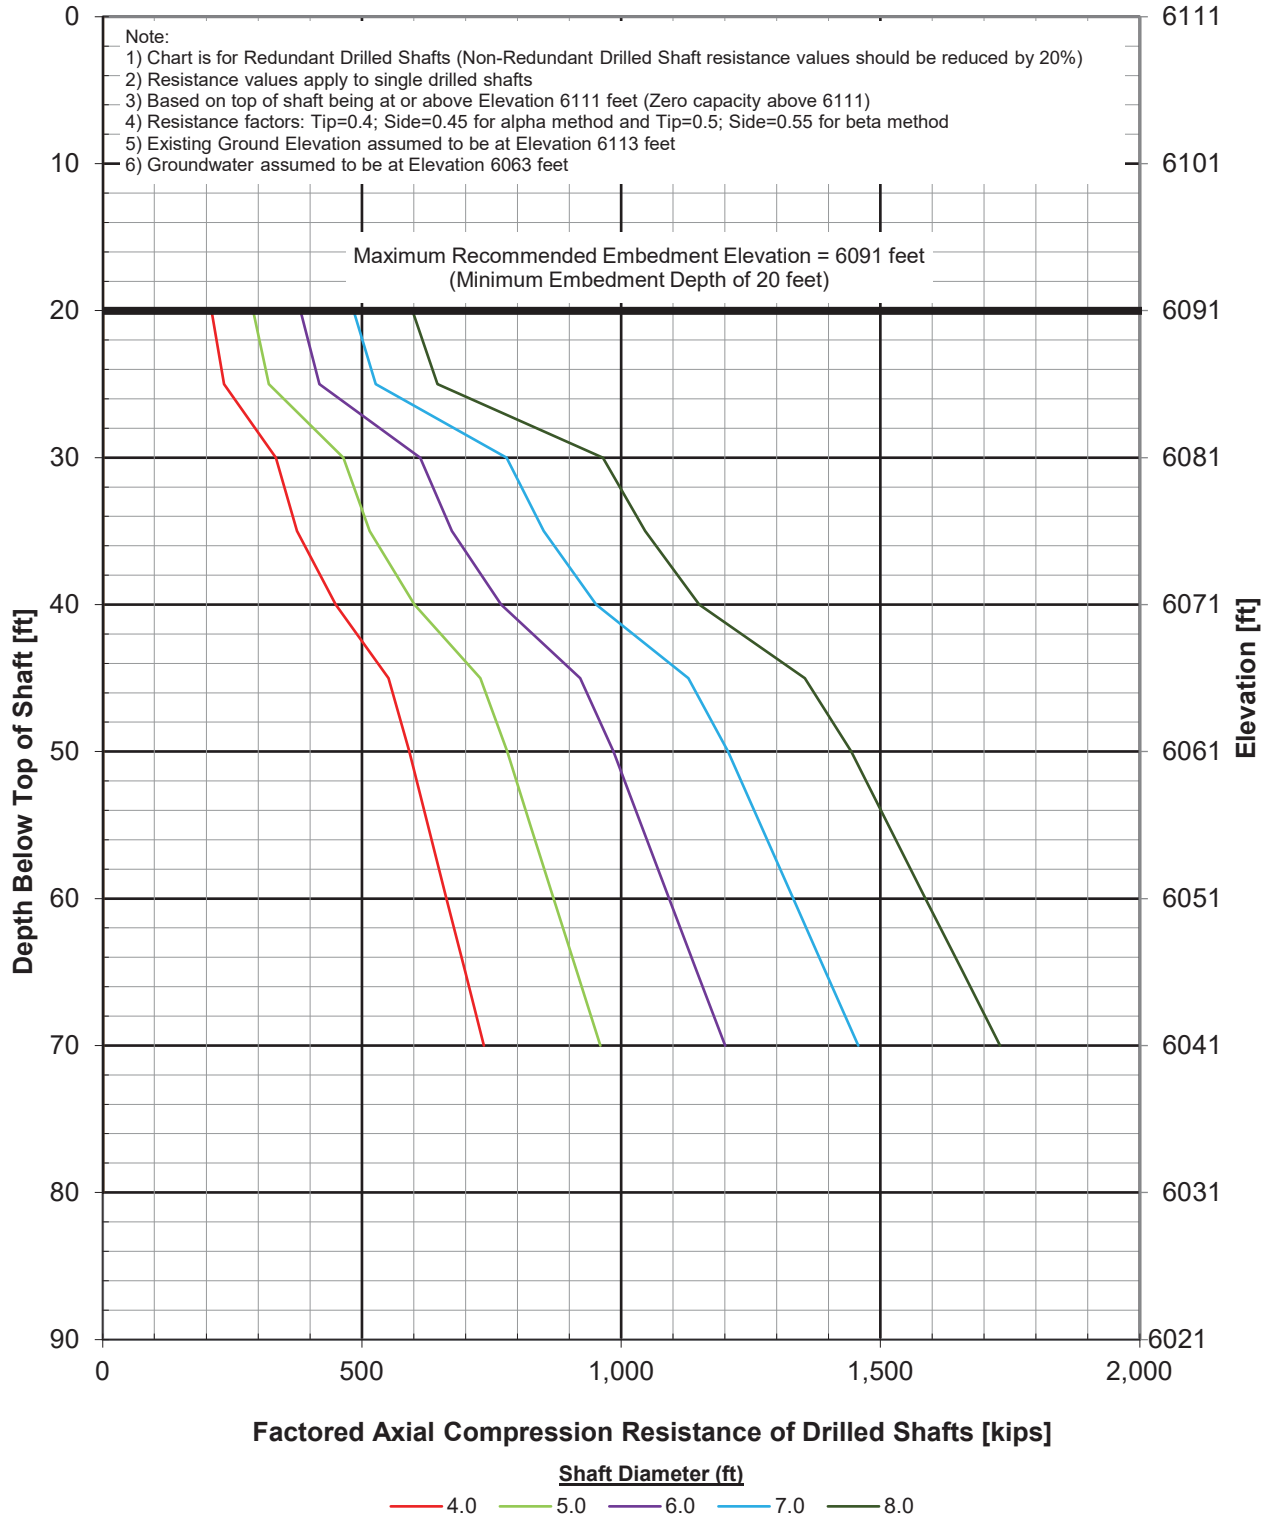
Design Chart 3 - STRENGTH LIMIT Allentown Bridge over I-40 Pier

A summary of the drilled shaft design charts is presented in Table 4.1. The drilled shaft design charts are presented in Appendix C by foundation element. Development of strength and service limit charts is further discussed in the following sections.
