## Report on Pavement Investigation

Designation: Stardust Pavement Evaluation

Location: Stardust Trail  
Flagstaff, AZ

Project Number: 220184SF

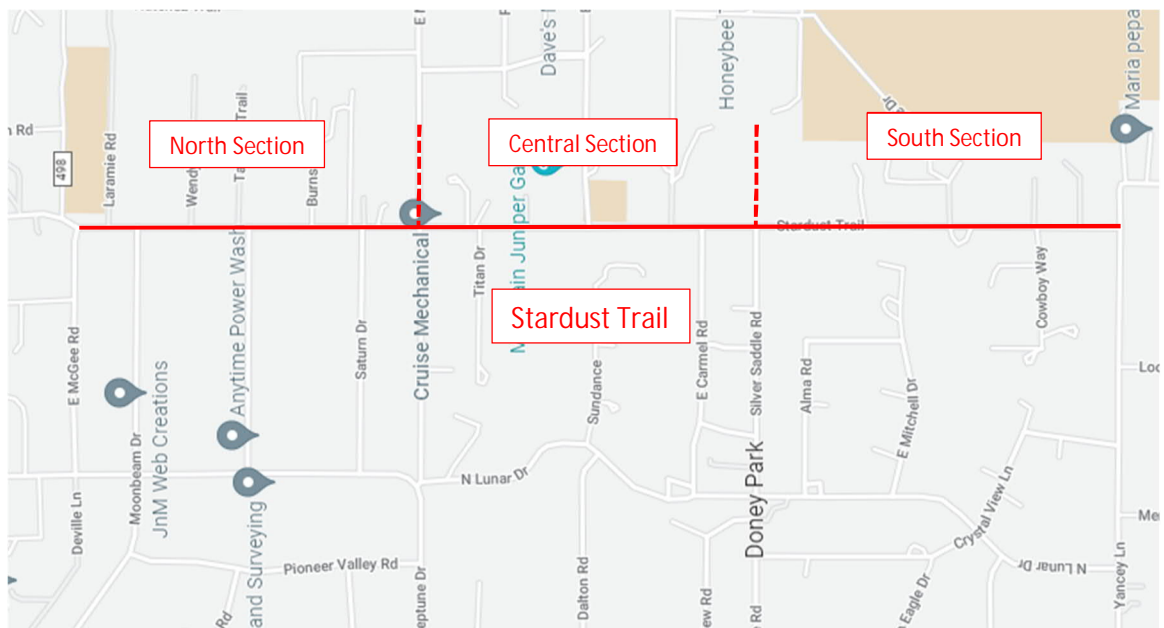
**Figure 2.1.1 – Project Limits.**

The subject roadway (Stardust Trail) is located within Doney Park and serves as a primary ingress and egress roadway for the surrounding community. The total length of the project is approximately 8,000 lineal feet. The road currently services primarily residential access to single family homes and is oriented in a north and south direction. The approximate limits of the project are shown in **Figure 2.1.1**. The southern limit of the project is the intersection of Stardust Trail and Yancey Lane and the northern limit of the project is the intersection of Stardust Trail and E McGee Road. Based on initial observations of the condition of the roadway and for the purposes of our analysis, the roadway was subdivided up in to three sections as shown in **Figure 2.1.1** (North, Central, and South).

The southern section of roadway, extending from Silver Saddle Road to Yancey, consists of two lanes with unpaved shoulders. Paving operations here occurred more recently, and the roadway is generally in good condition over this length with only some localized areas exhibiting distress. Buried utilities were noted to run adjacent to the roadway with frequent lateral services crossing the roadway. The roadway contained no curbs, and runoff will flow along the pavement or into roadside ditches and/or the large drainage channel on the west edge of the road. In general, the road was noted to sit several feet higher than the adjoining properties, only matching grades where driveway access was required.

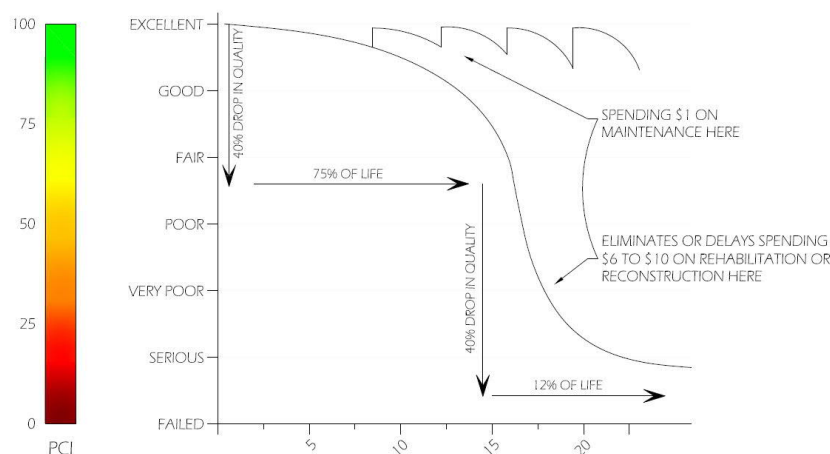
**Figure 4.4.4.1 – Life Cycle Cost Analysis**

It has been well documented that proper maintenance will prolong the life of the pavement at a lower cost than letting the pavement age with no maintenance. **Figure 4.4.4.1** shows how spending money on pavement preservation at the correct time will be a more cost effective means for extending the life of the pavement. As long as the pavement remains in a fair to excellent state, the cost of pavement preservation is relatively small. However, as the pavement deteriorates into the fair to poor range, the pavement life becomes significantly shorter and there is a change from preservation to pavement rehabilitation and reconstruction (at a significantly higher cost).

Once the pavement enters into this middle zone, light pavement preservation techniques, such as seal coats, crack sealing, etc. become a poor use of funds and the process results in chasing the distress rather than permanently fixing it. This will result in the owner spending more money just to maintain the current, and likely unsatisfactory, pavement condition. **Figure 4.4.4.1** provides a Pavement Condition Index (PCI) rating, which is a visual condition scale rating from 0 to 100, with 100 being a brand new pavement and 0 being a completely failed pavement. The PCI is one of several standardized methods for rating a pavement based on a visual condition survey of the pavement. The rating procedure uses the pavement distress type and severity to calculate an index score (PCI) for the pavement.
